M300 RTK Known Issue List

| Released date | 2021.03.05 |
| Aircraft Firmware: | v02.02.02.01 |

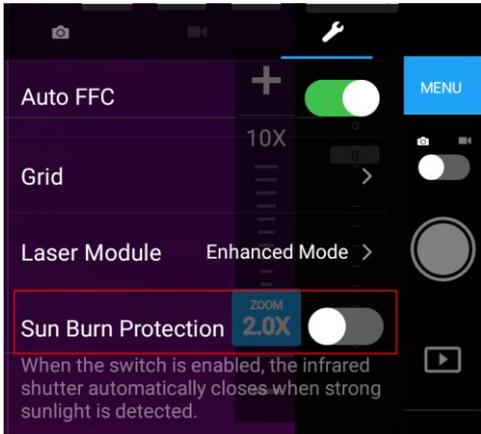
| 1. | When H20T is aimed at an object with a high temperature, the Sun Burn Protection function may be triggered, and there will be an option to allow you to disable the protection. However, after you disable it, later the Protection will still be triggered. | <p>Please disable the Sun Burn Protection function in the camera setting page.</p> |
